ADEPT HOME INSPECTION, INC

Report # : Sample Report (actual)

Maricopa, AZ 85239

Report Overview

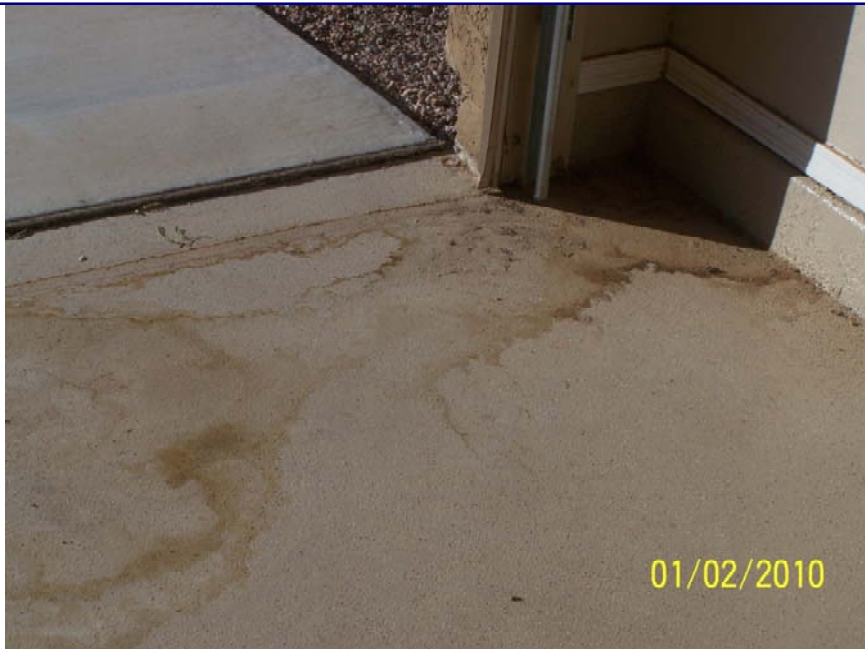
Picture 2

Floor settled/poor drainage in
garage, Page 14.57 Floor

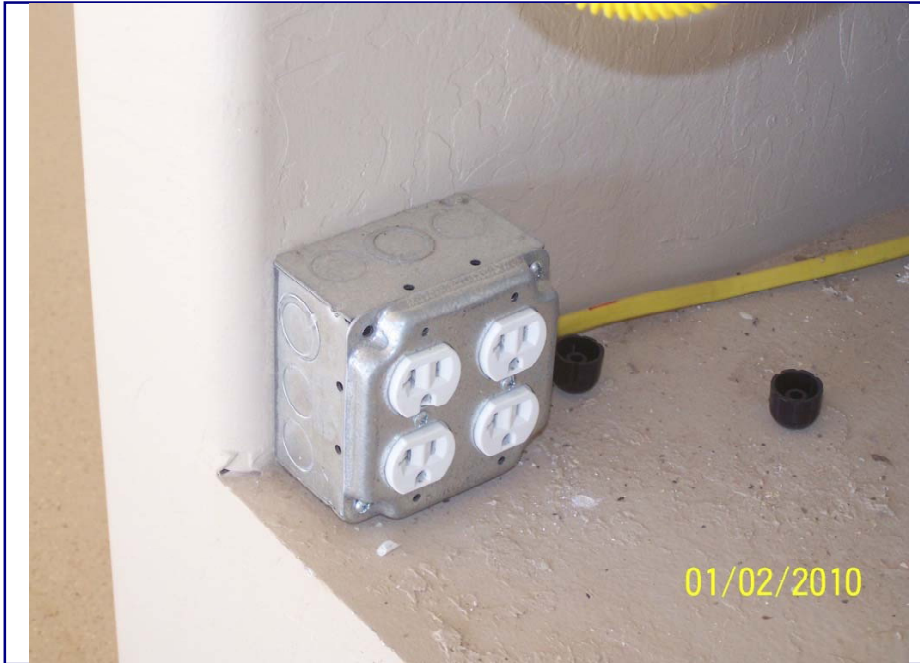
Picture 3

Exposed wiring in garage,
Page 14.64 Electrical

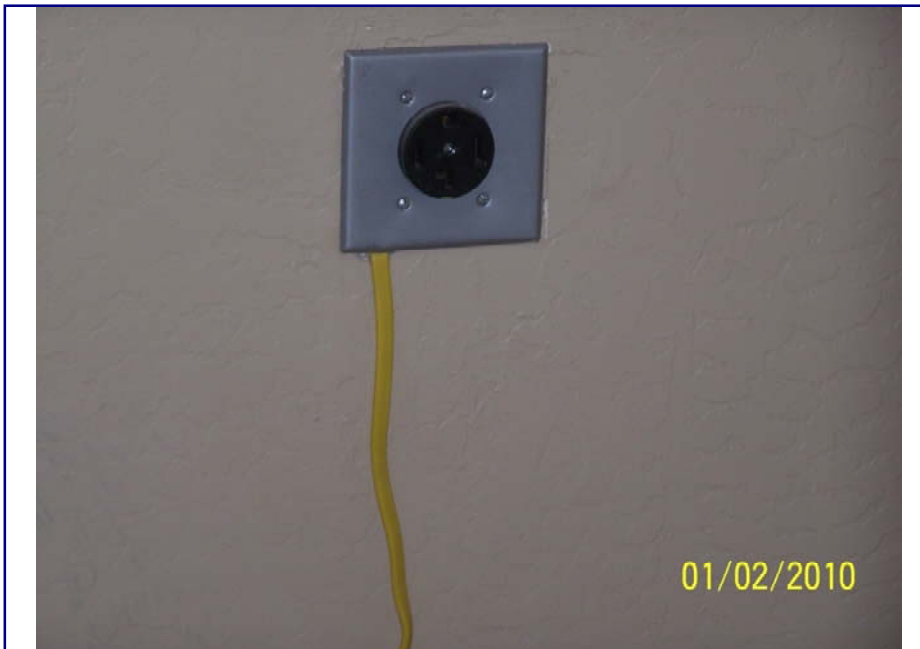
Picture 4

Added junction box tapped
into dryer outlet in garage,
Page 14.64 Electrical

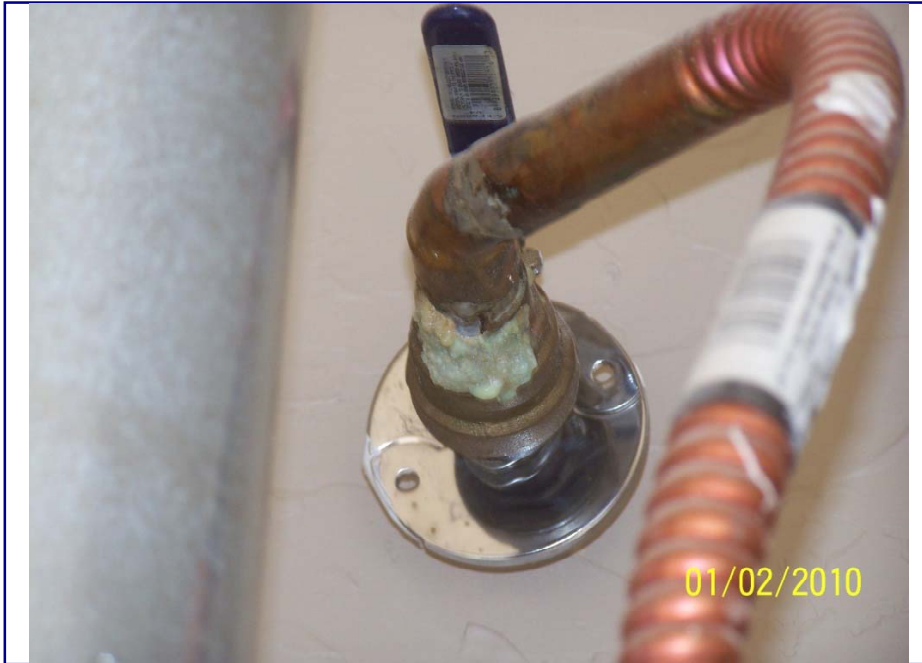
Picture 5

Comments: The water heater had corrosion on pipes and valves at the time of the inspection.

Corrosion on pipes, Page 8.27
Water Heater

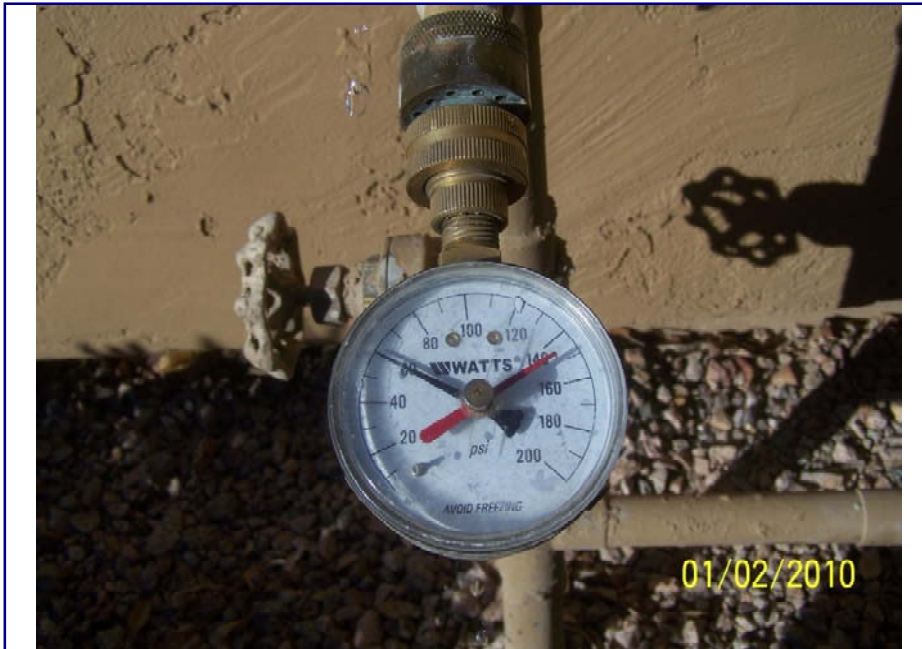
Picture 6

23 Main Line☐ N/A**Main pipe is Copper****Size: 1 1/4" Pressure: 66 PSI** ☒ AM ☐ PM☐ Pressure is above 80 psi - recommend

Water pressure 66 PSI, Page
8.23 Main Line

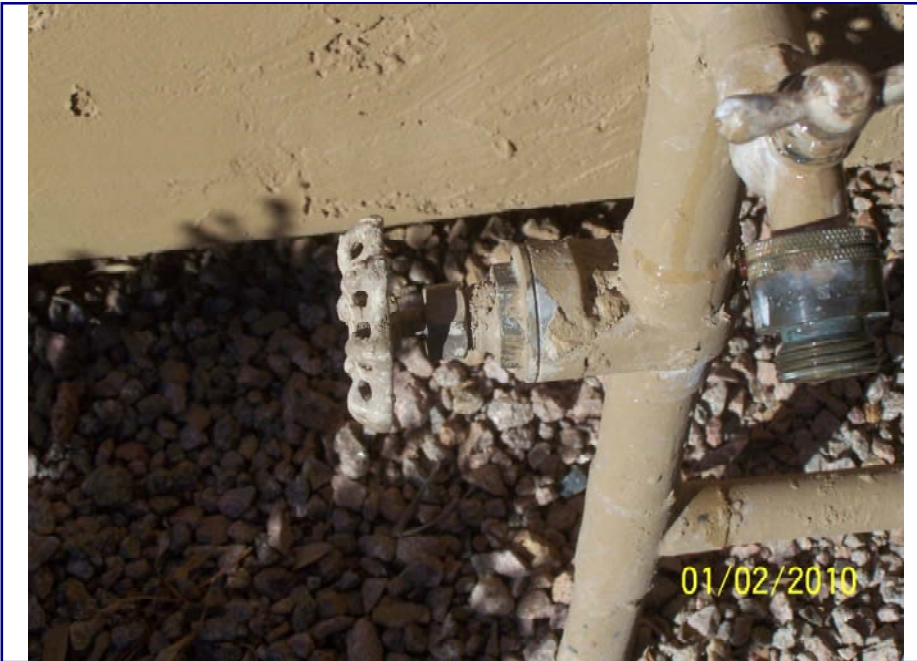
Picture 7

- ☒ **Appears serviceable** ☐ Not Functional* ☐ Unsafe* ☐ Worn* ☐ Near end of lifespan* ☐ Not fully visible*
☒ Main valve location: East Side ☐ Not located* ☐ Operational ☒ Not operational (2) ☐ Not inspected*
☐ Handle is ☐ Excessive corrosion on valve (2) ☐ Copper pipe not protected from concrete*
☐ Water softener installed (water condition/quality is not tested*) ☐ Leaks at main valve (2) ☐ Leaks at water conditioner (2)

Valve not operational, Page 8.23 Main Line

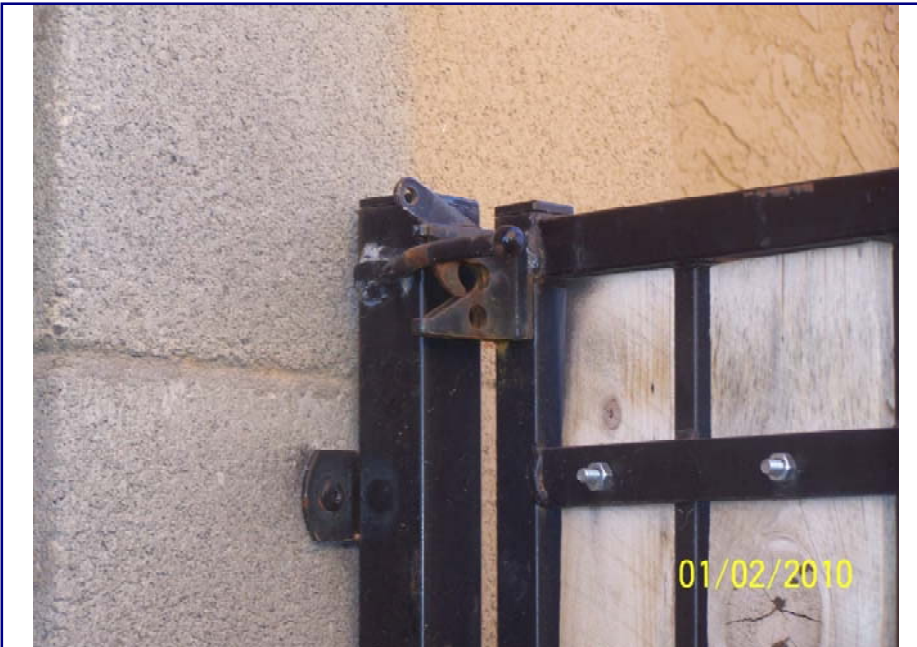
Picture 8

Gate latch needs adjustment, Page 4.7 Fences & Gates

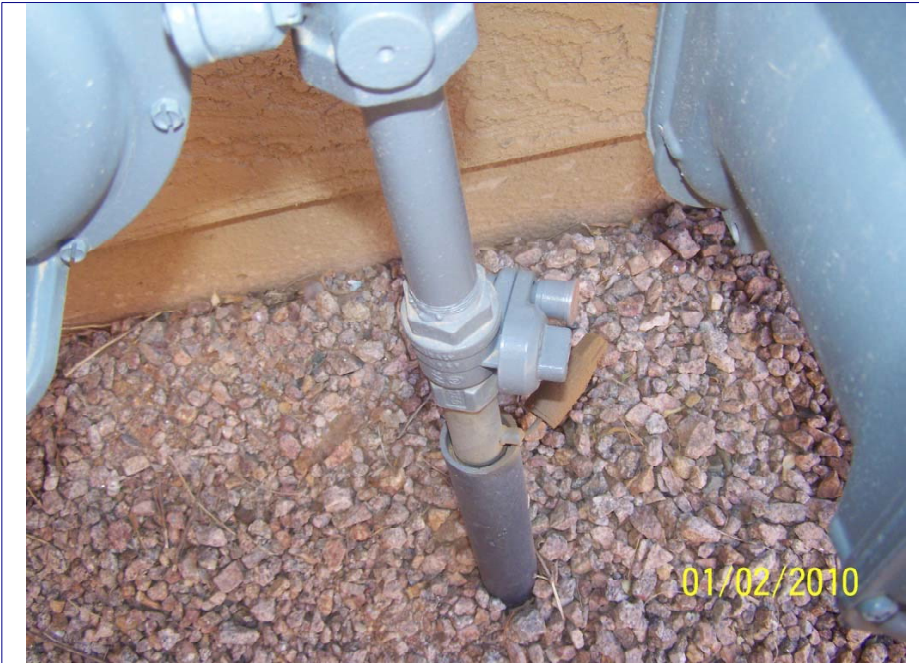
Picture 9

Gas meter off at time of inspection, Page 8.26 Fuel System

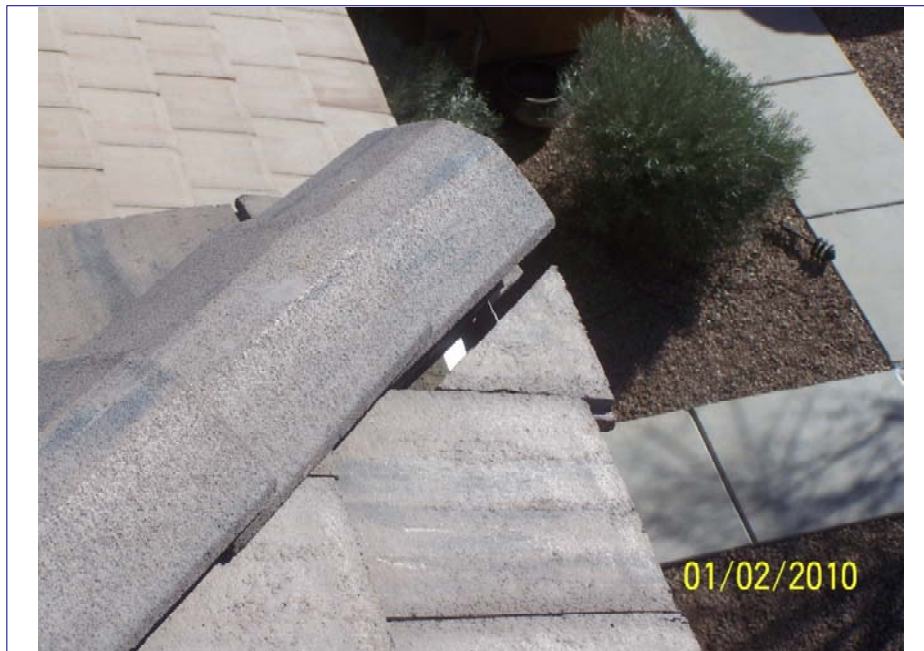
Picture 10

Comments: SE hip tile loose, W gable with cracked/broken tile

Loose tile at SE hip, Page 7.20 Main Roof

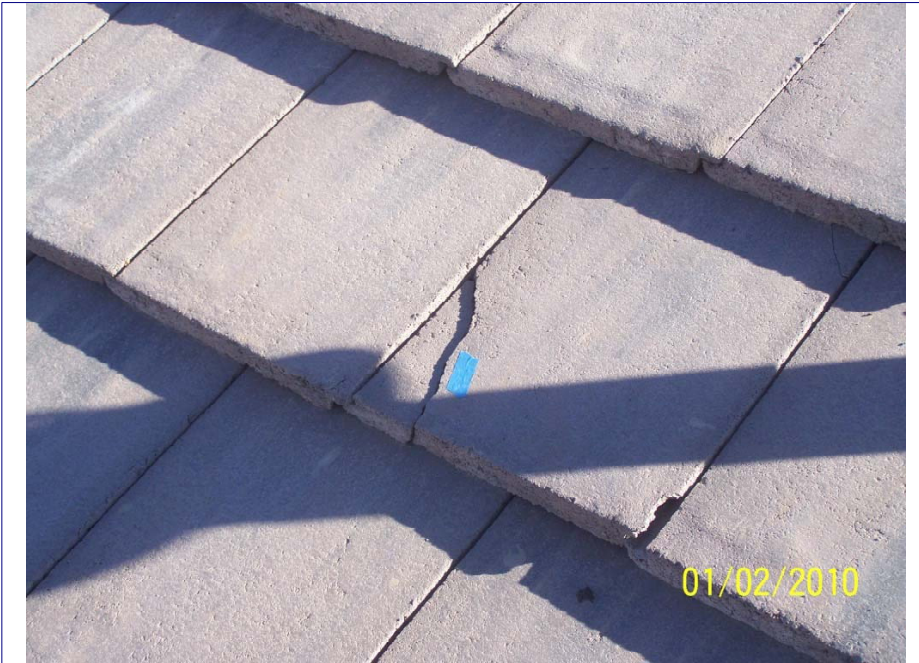
Picture 11

Broken, cracked tile at W
gable, Page 7.20 Main Roof

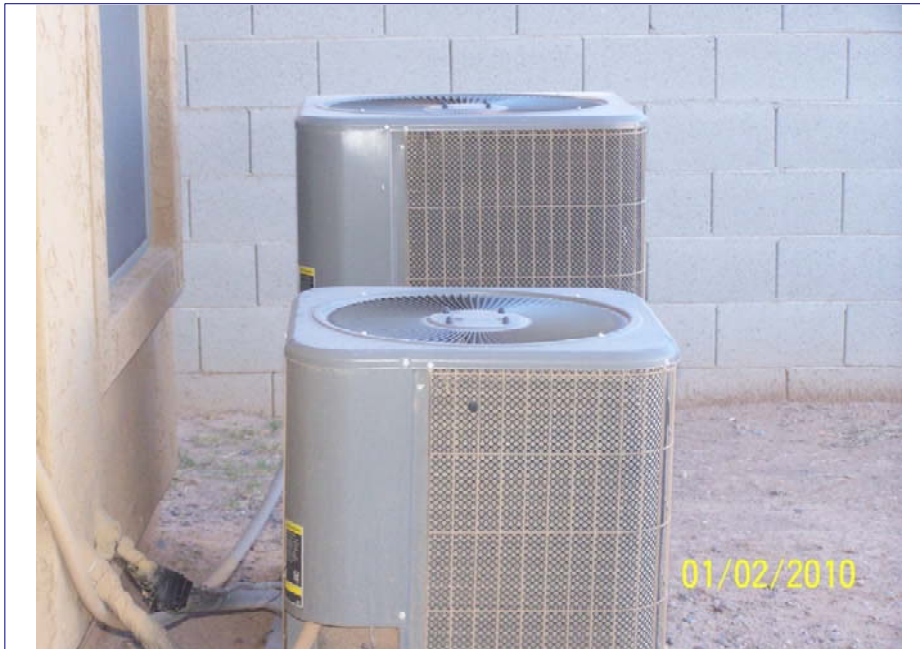
Picture 12

AC unit not level, Page 10.38
Air Conditioning

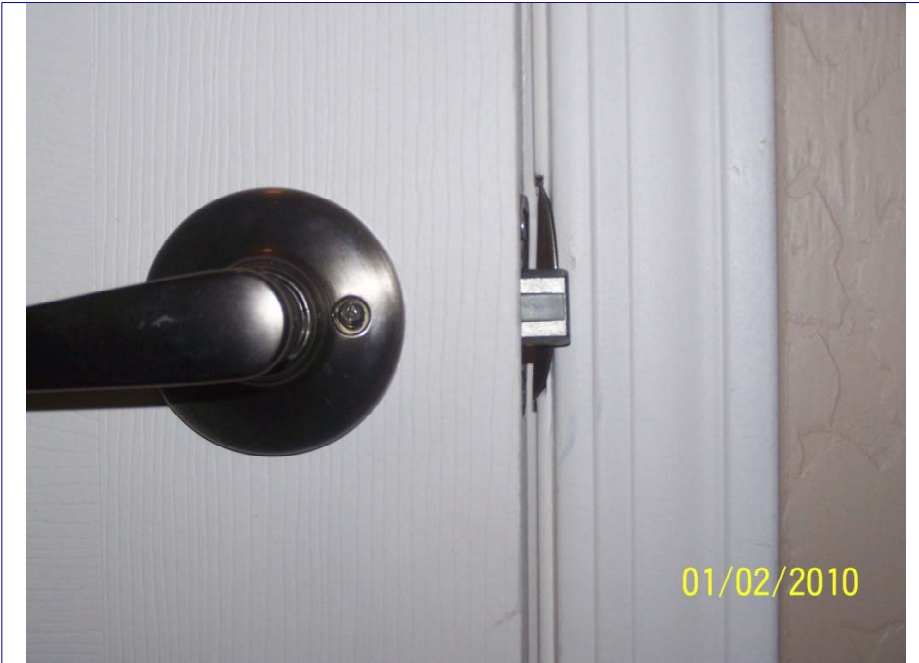
Picture 13

SE bedroom closet door won't latch, Page 12.46 Doors

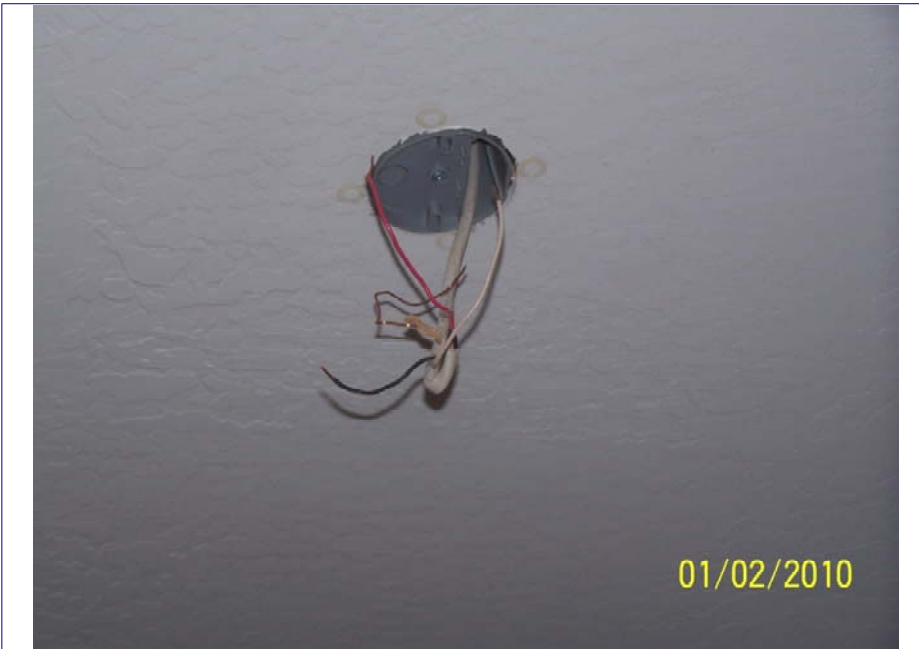
Picture 14

Exposed wiring at family room, Page 11.44 Wiring Notes
